EVALUATION TESTING OF
SOLID ENCAPSULATED MICROCIRCUITS
FOR SPACE APPLICATIONS

FINAL TECHNICAL REPORT
CONTRACT NUMBER NAS8-31627
JUNE 1975 - May 1977

Donald D. Robinson
Electronic Parts and Subsystems
Central Laboratories
Boeing Aerospace Company, Seattle, WA 98124
May, 1977

Prepared For
National Aeronautics and Space Administration
George C. Marshall Space Flight Center
Marshall Space Flight Center, Alabama 35812

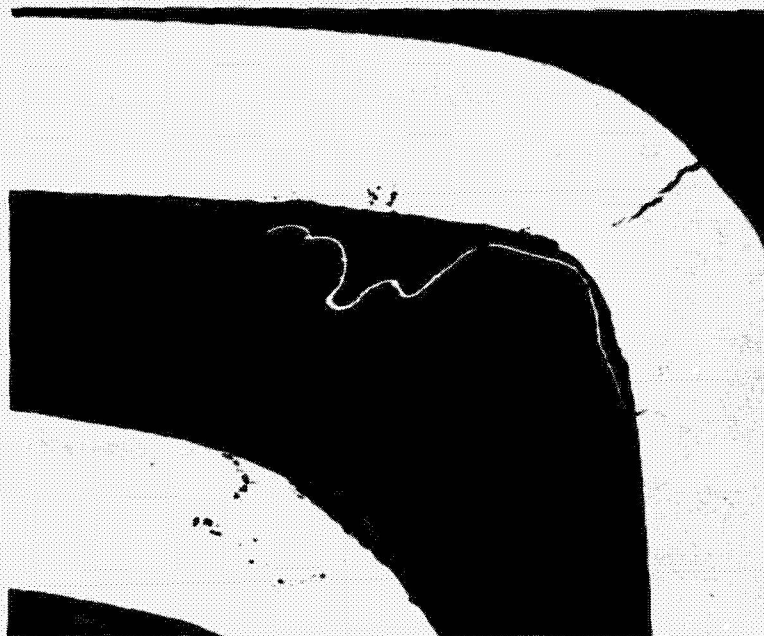
Figure 2-9. Stress Corrosion Cracking and Plating Degradation

The Manufacturer A parts experienced severe degradation of the external leads after the 175°C operating life test increment of Group 206. Metallurgical analysis showed the problem to be caused by stress corrosion cracking of the leads accompanied by severe breakage of the leads. The stress corrosion cracking was determined to be caused by chlorine present under the silver plating on the leads. It is postulated that an improper cleaning procedure resulted in inadequate removal of a chlorine-containing cleaning solution applied after the silver plating was applied. Wherever there were breaks in the silver plating, the chlorine attacked the Alloy 42 (iron-nickel) lead material causing transgranular cracks shown in Figures 2-9 and 2-10.

This occurrence of stress corrosion cracking at 175°C must be considered in procurement controls on encapsulated microcircuits, since it represents a good example of how an uncontrolled part type can demonstrate anomalous failure mechanisms. The activation energy of the stress corrosion cracking phenomenon is not known, hence it is not possible to extrapolate the observed 175°C failures down to normal system operating temperatures. However possibility of long term exposure to normal system operating temperatures causing stress corrosion cracking seems to exist, and precautions should be taken to avoid use of lots of parts which have latent stress corrosion cracking possibilities.

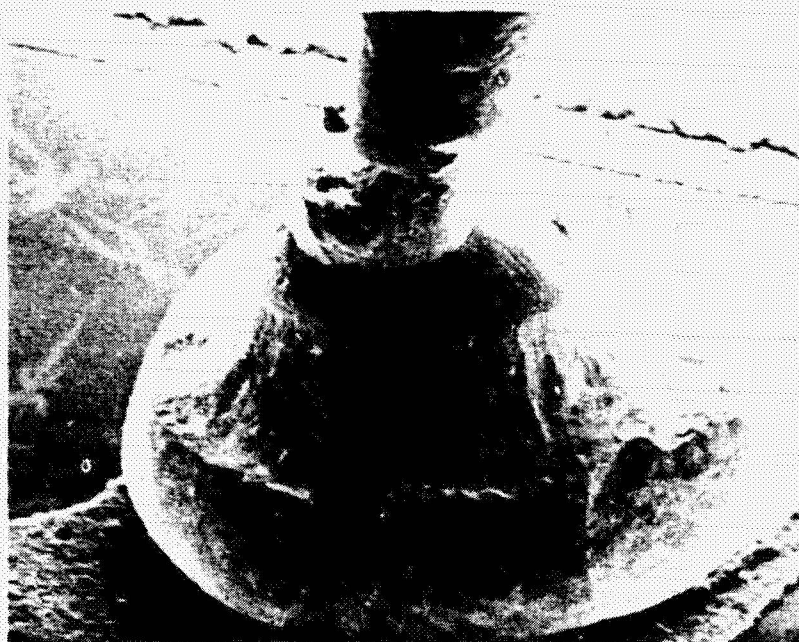
Figure 4-14. Group 202 Representative TTL, CMOS and Linear
Broken Wire Failures

- (a) Mfr. B, Serial Number 659. TTL 5400
Previous Environmental Stress: 2000 cycles each at -55°C to $+125^{\circ}\text{C}$
 -65°C to $+150^{\circ}\text{C}$
 -65°C to $+200^{\circ}\text{C}$

Many of the failures due to broken wires were only observed during the +125°C electrical measurement, indicating that at -55°C and +25°C the broken wire ends were making adequate enough contact to avoid detection. Since "hot intermittent opens" (HIO) failures were commonly observed with pre-novolac encapsulated microcircuits, the occurrence of these failures at +125°C only is of concern. Figure 4-17 shows the number of "+125°C only" (or HIO) failures that occurred.

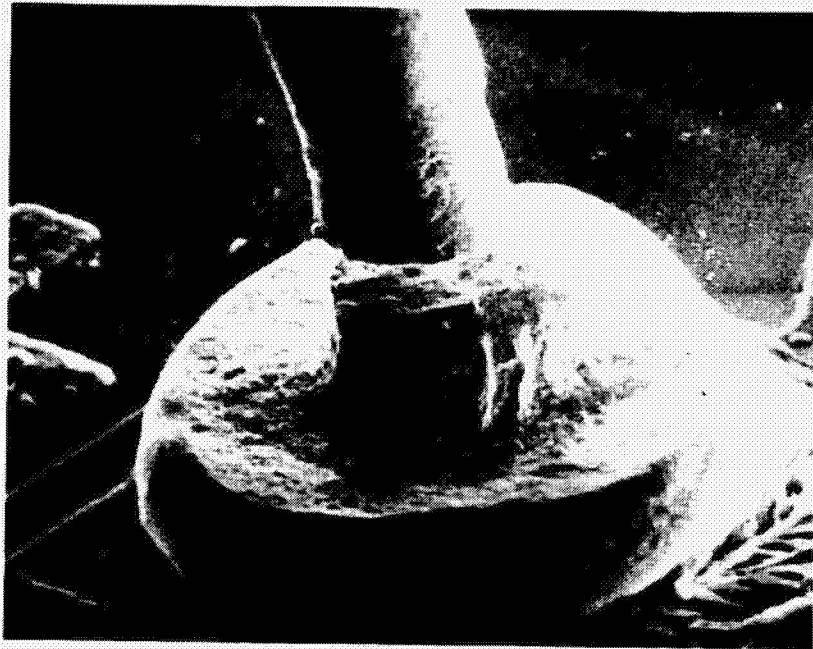
(c) Mfr. E, Serial Number 2232, CMOS 4007

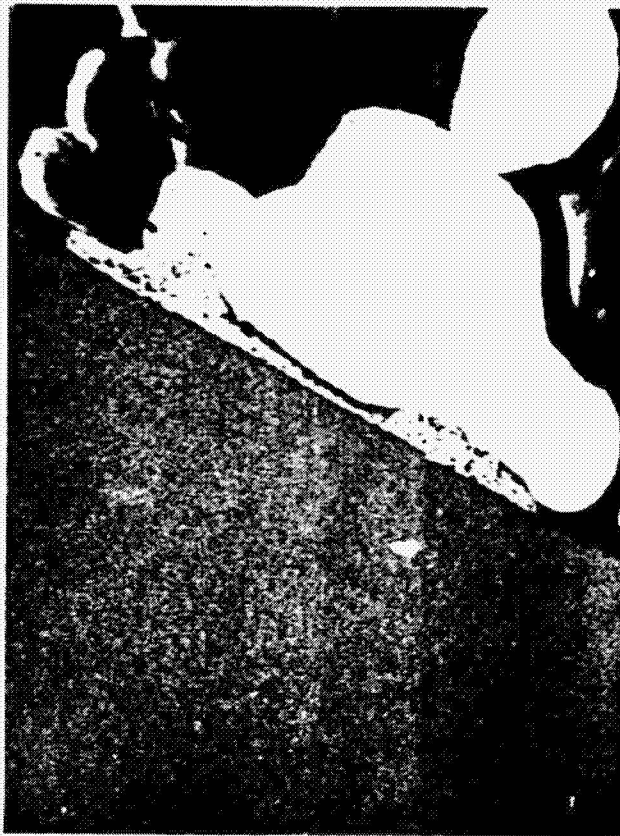
Figure 4-22 Group 206 TTL Mfr. B Failure: Plastic Plague

TTL 5400

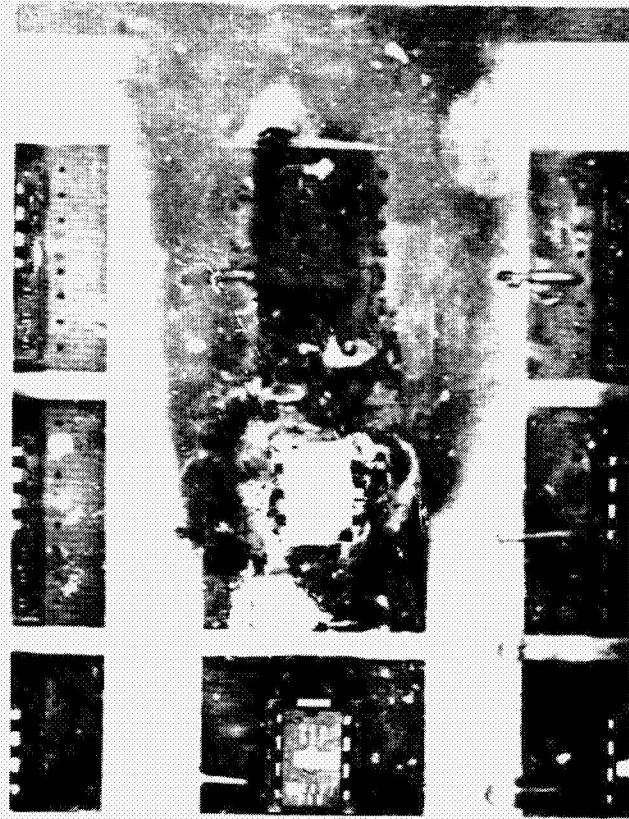
Linear 741
Manufacturer C

Cause of Failure: Thermal Runaway, combustion of encapsulant and massive electrical failure.
